CP-800 USB detection and connection to a computer

Service Notice # 0011

Release date: September 17, 2014

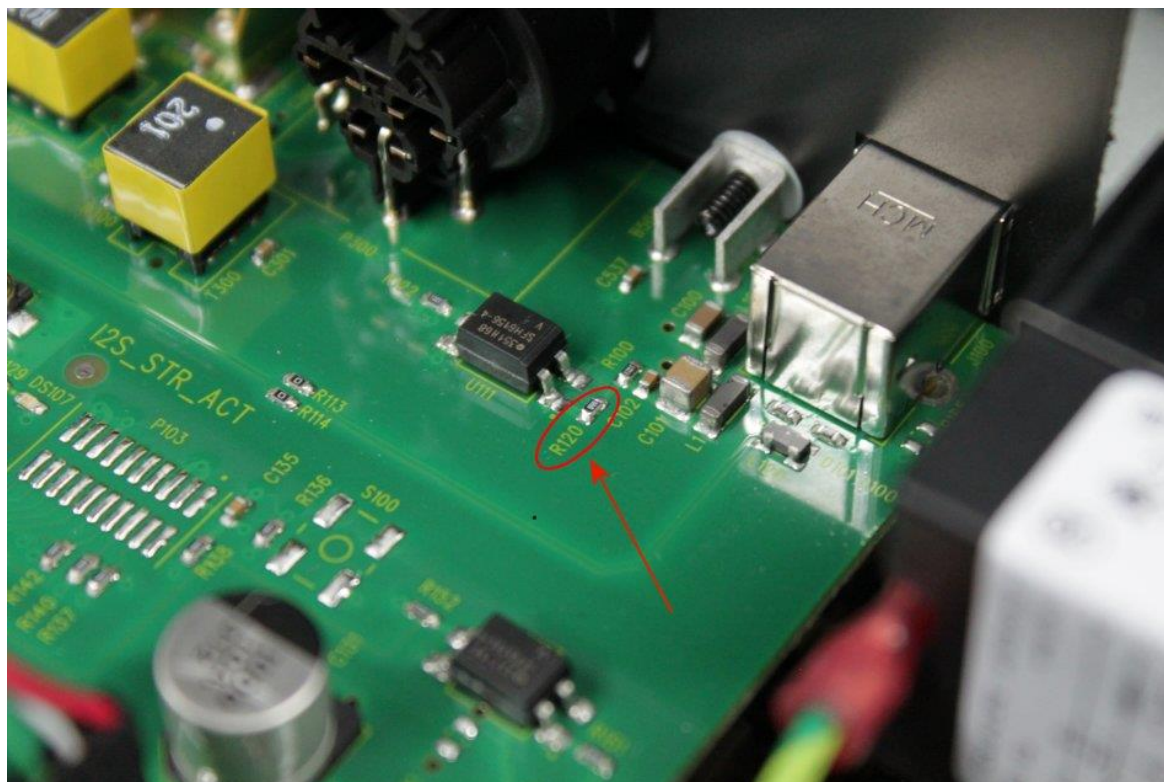
The computer will sometimes be unable to detect the CP-800 via USB.

A drop in the computers USB +5VDC supply over a lengthy USB cable may cause an under-voltage condition in the CP-800s USB detection circuit.

On location R120, replace 2K2, p/n G211-1750-XR00 (RMC1/162K201%R) with
825 ohm, p/n G211-1917-XR00 (CR0603F8250T1LF).
