Audible buzz heard from chassis with CA-D200, AMP2 and AMP5

Service Notice # 0015

Release date: April 9, 2015

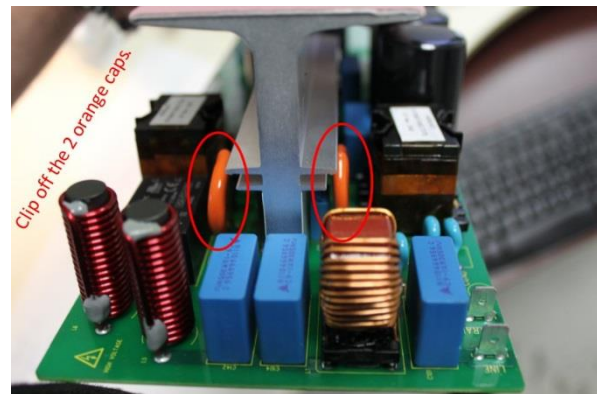
2. On power supply board R8601, clip the 2 orange capacitors (C54 & C63) with appropriate cutters.

SOLUTION:**Power supply capacitors**

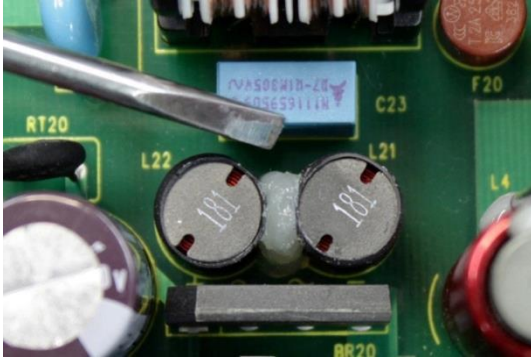
Step 1) Locate inductors

Sigma AMP2/CA-D200 inductors

Some AMP2/CA-D200's will already have silicone applied but it may be insufficient. If this is the case, carefully remove the silicone with a small flat blade screwdriver or similar tool. Follow steps 1 & 2. Add silicone around L202 and L203 of R8602 (AUX power supply). The silicone should flood the area and make contact with the bridge rectifier (BR201) and the blue capacitor (C202) that are located on either side of the two inductors. Follow steps 3 through 5.

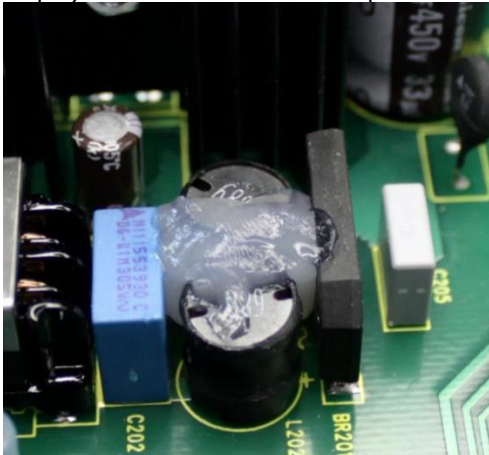
Step 5) Make sure the silicone couples with the bridge rectifier and capacitor.

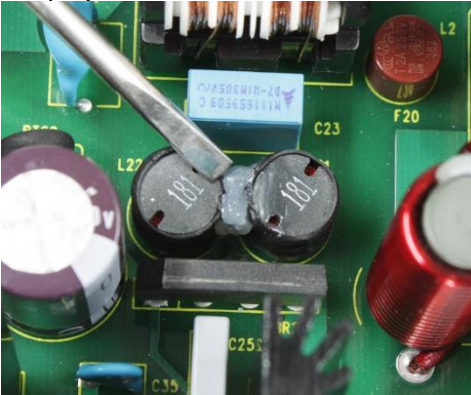
Step 1) Locate inductors

SIGMA AMP5 inductors

Some AMP5 amplifiers will already have silicone applied but it may be insufficient. If this is the case, carefully remove the silicone with a small flat blade screwdriver or similar tool. Follow steps 1 & 2. Add silicone between L21 and L22 of R8702 (AUX power supply board). The silicone should flood the area and make contact with the bridge rectifier (BR20) and the blue capacitor (C21) that are located on either side of the two inductors. Follow steps 3 through 5.

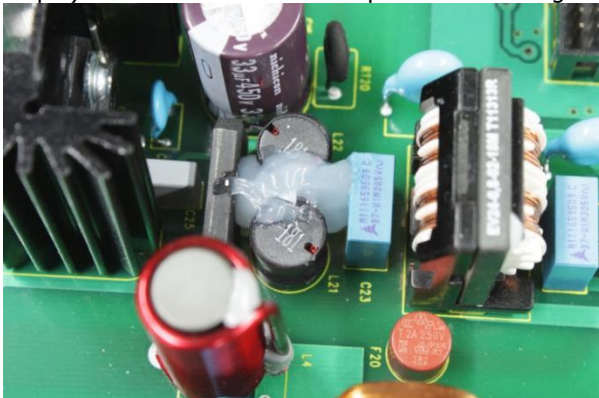
Step 5) Make sure the silicone couples with the bridge rectifier and capacitor.
