Noise heard through speakers while utilizing CANBUS with CA-D200, AMP2, AMP5

Service Notice # 0012

Release date: March 26, 2015

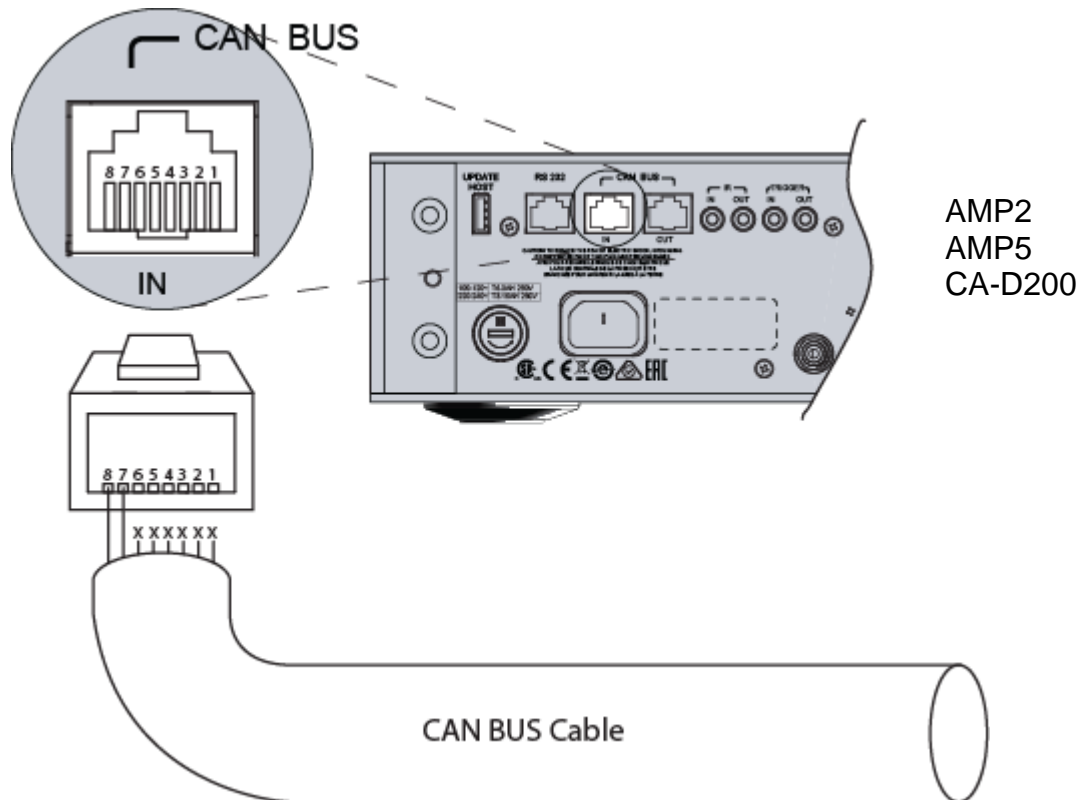
A ground loop is caused when connecting CANBUS to the CA-D200, AMP2 or AMP5.

Create a custom CAT-5 cable with only pins 7 and 8 connected at amplifier end.
